**MIDDLE NORTH SERIES  
DIAL PACK EVENT**

**PROJECT OFFICERS REPORT**

**PROJECT LN-318**

**TEST OF PRECAST CONCRETE  
UNDERGROUND STRUCTURE (U)**

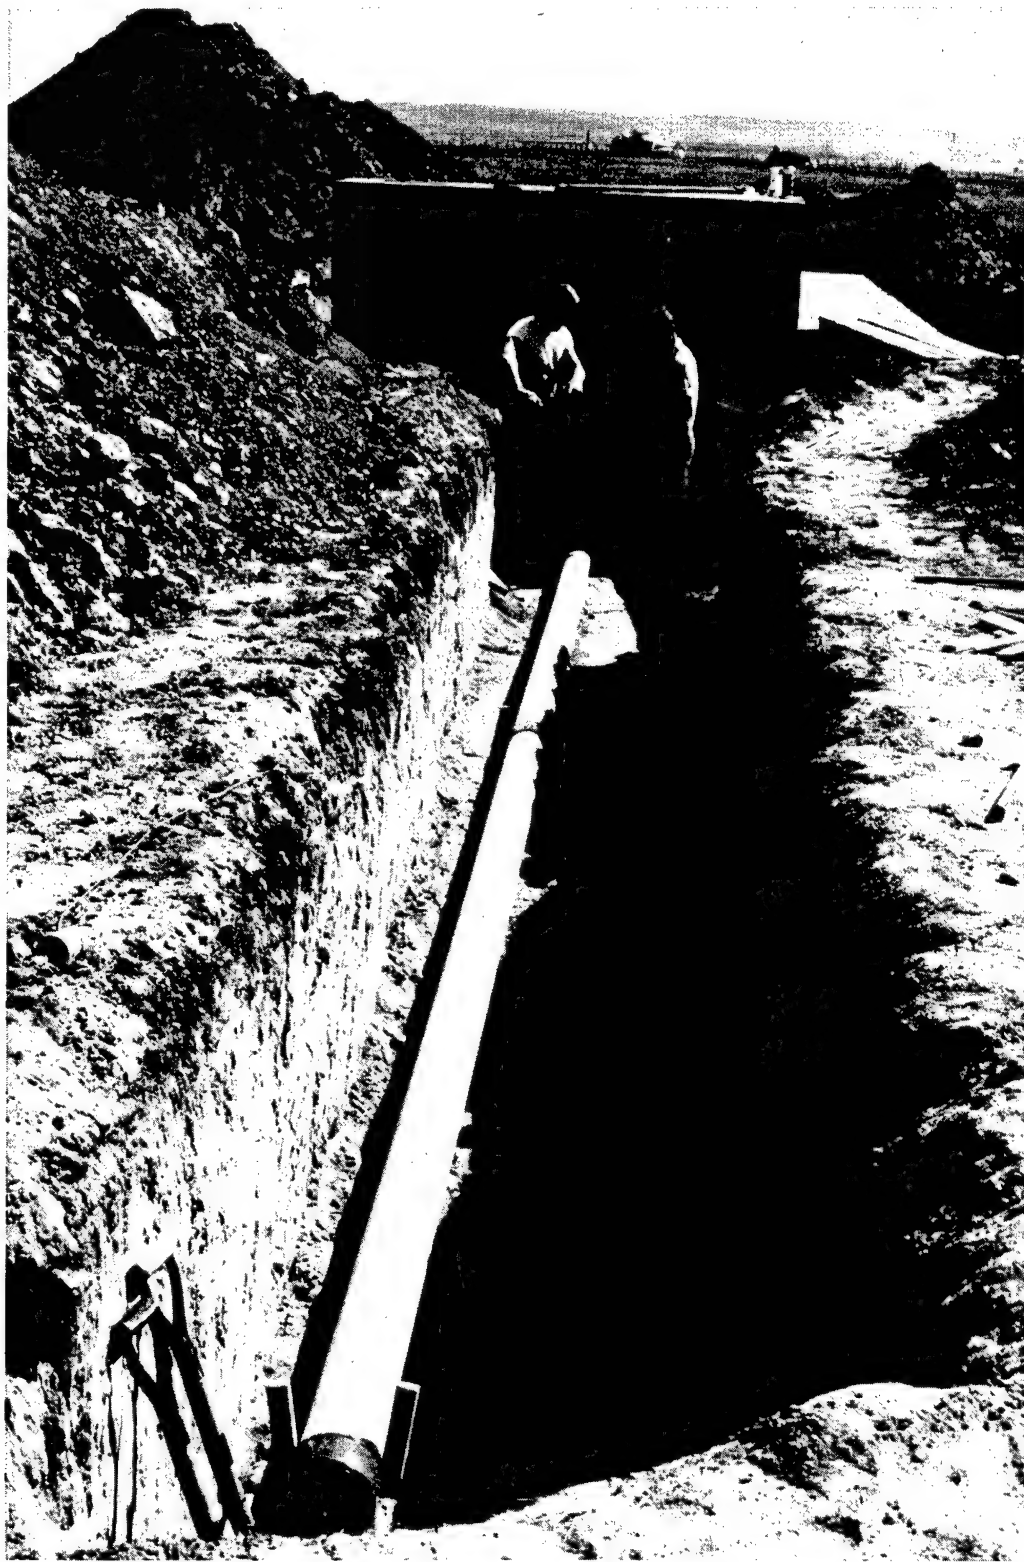
Figure 17. --Installation of the PVC conduit.

Figure 17 shows a view of the installation of the PVC conduit.

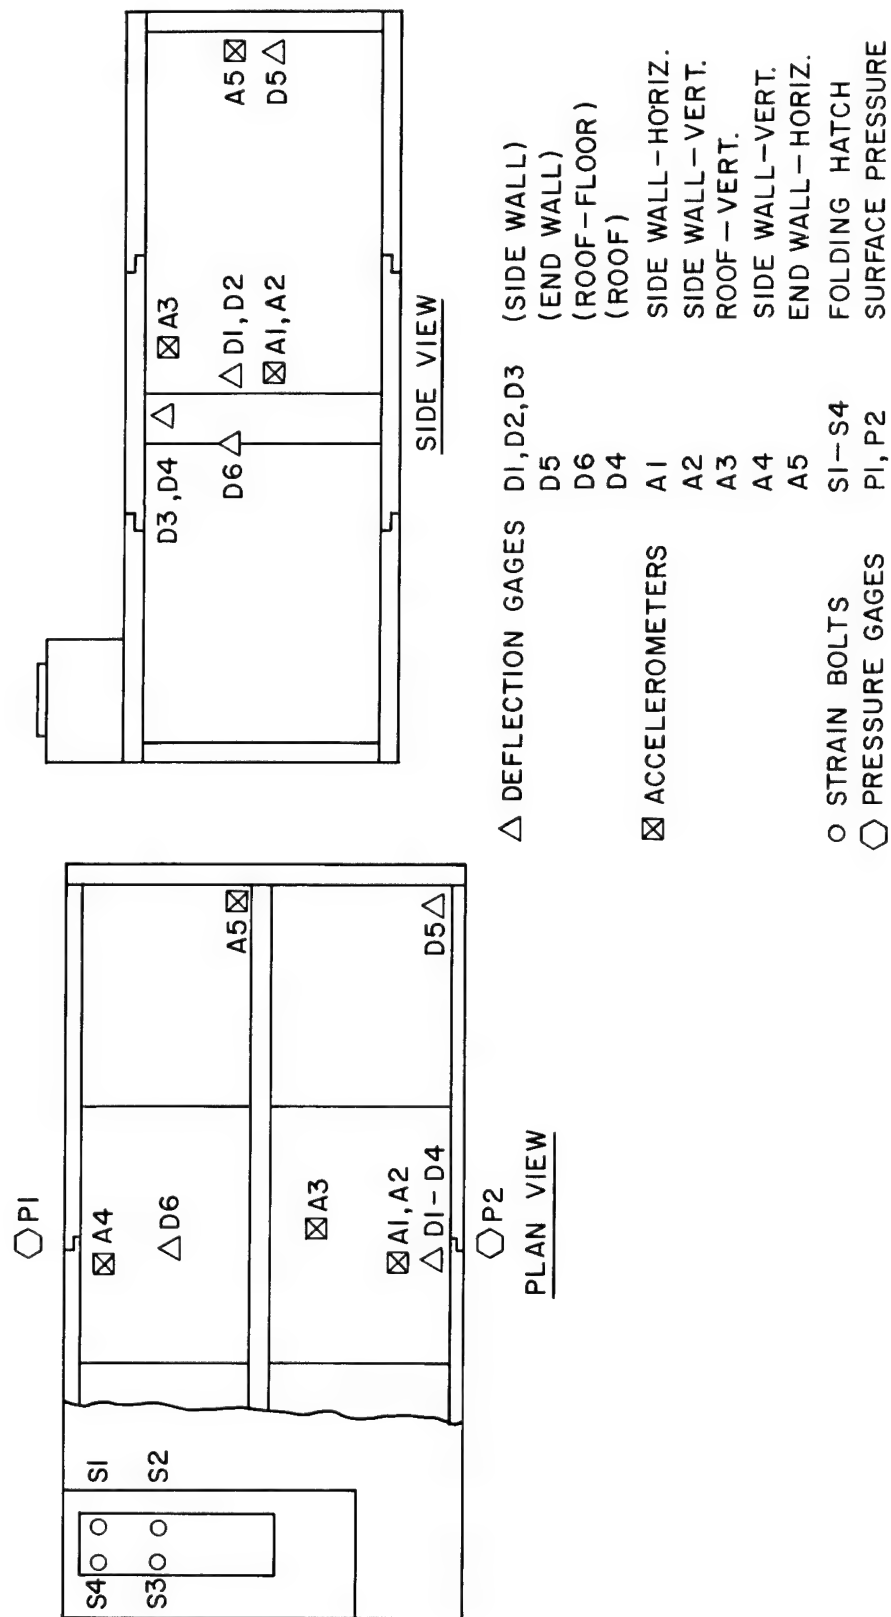
Figure 18. --Instrumentation.

The location of all instrumentation for this project is shown in figure 18. The deflection gages in the structure were used primarily to determine relative movement between the side wall, end wall, roof, and base slabs. Gages D1 through D5 were of the cantilever beam type with two SR-4 strain gages cemented on the top and underside of the beam. One end of the beam was fixed securely on a slab, while contact to the adjacent slab was made by means of an adjustable screw with a pointed tip through the free end of the beam. The pointed tip engaged a blued steel plate which also provided a scratched record of deflections perpendicular to the movement of the cantilever beam. Gage D6, which measured displacement between the floor and roof of the structure, was of a slide-wire potentiometer type. Prior to the detonation, all deflection gages were calibrated and initial deflections applied to permit both positive and negative movements of the slabs to be recorded.

- D1, D2 Horizontal deflection of side walls in two directions.
- D3 Vertical roof deflection relative to side wall.
- D4 Horizontal side wall deflection relative to roof.
- D5 Horizontal deflection of end wall relative to side wall.
- D6 Vertical displacement between roof and floor.

Accelerations A1 through A5 were measured at the locations and in the directions shown. Surface pressure gages P1 and P2 were placed along the expected 60-psi overpressure range and about 5 feet from each side wall of the structure.

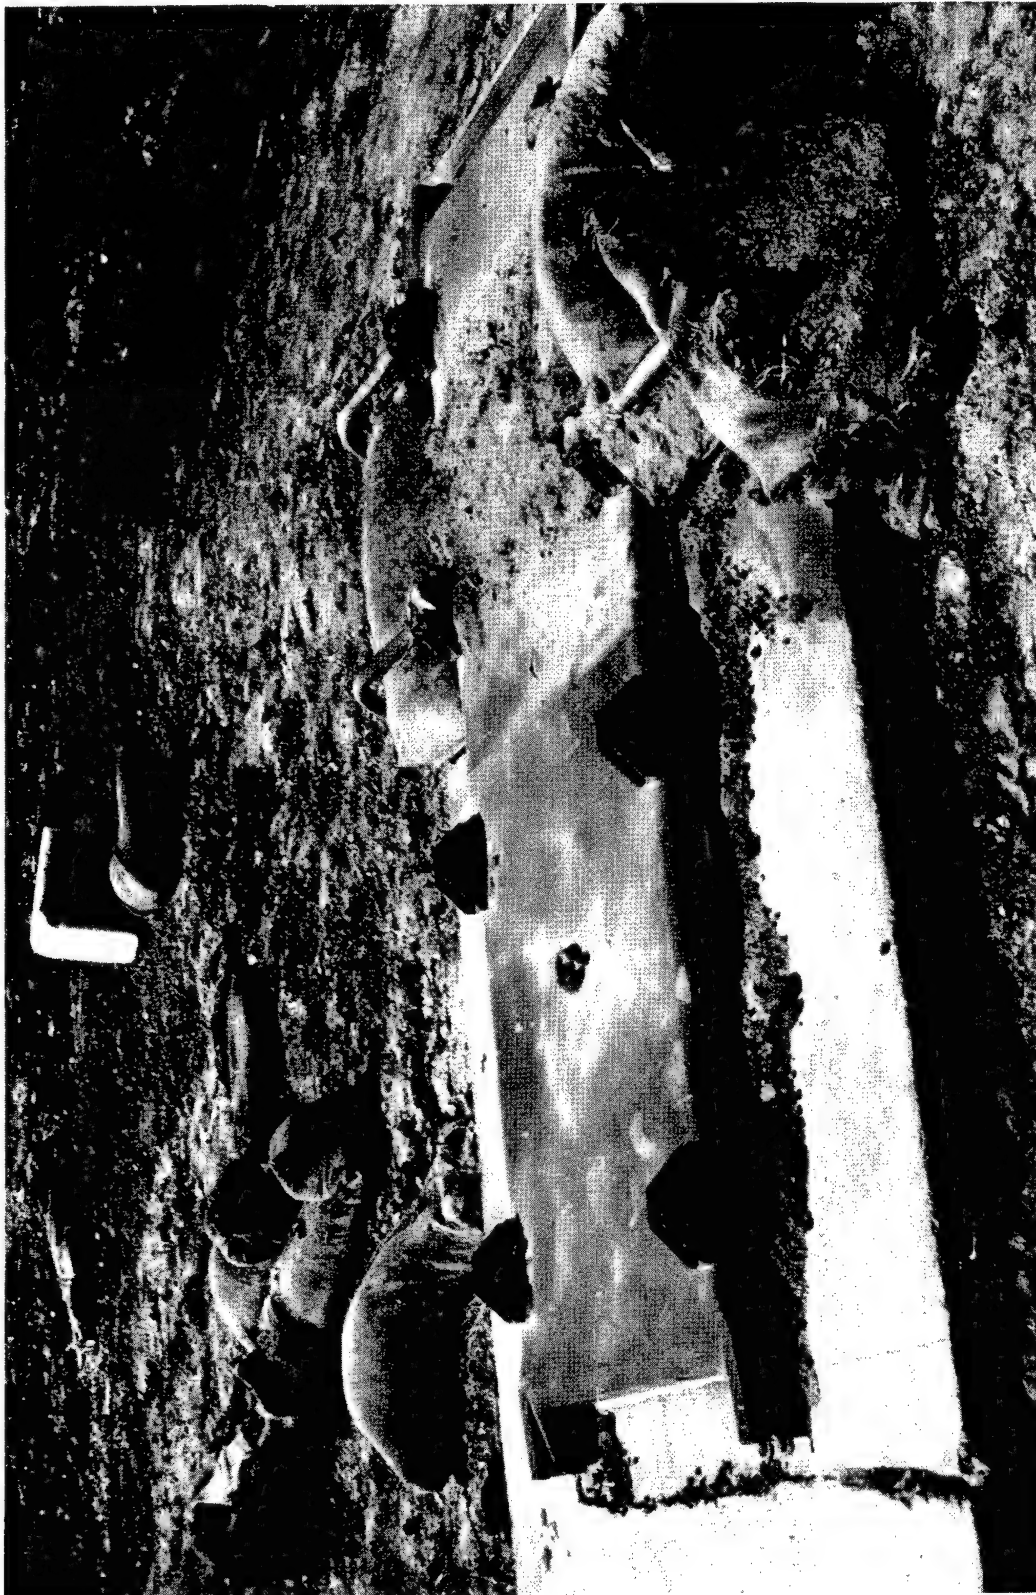
Figure 19. --Postshot view of the blast hatch.

Figure 19 shows a postshot view of the blast hatch. The hatch cover did not sustain damage and was still secured in place after the blast. The strain bolts, which had been preloaded to 1,000 pounds each, indicated very little rebound loading due to the blast. See table 1 for recorded measurements.

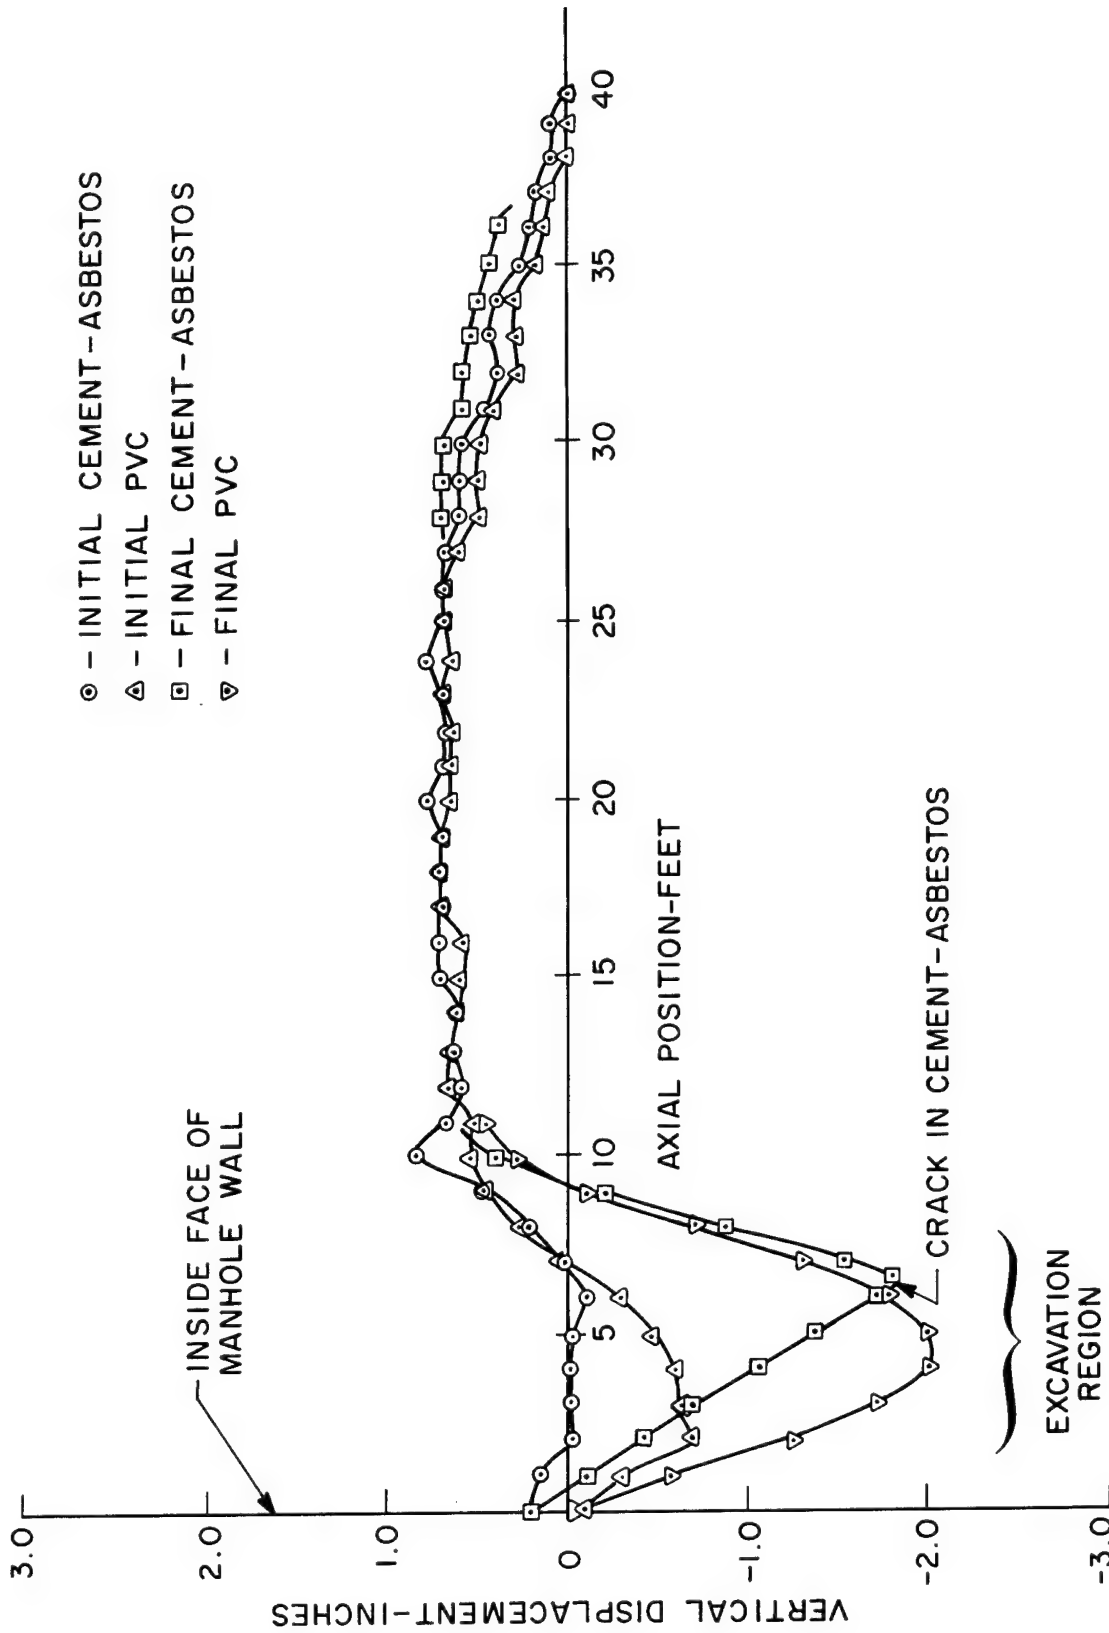
Figure 20. --Main conduit vertical axial deformations.

In figure 20 the vertical axial deformations of the main conduits are shown. It was found that there were virtually no changes in the configurations of the two conduits over the full length in the horizontal plane (not shown) and over all but the first 10 feet in the vertical plane. Not only did substantial vertical deformation changes occur in the excavation region due to the blast, but initial alignment there was much more irregular. A circumferential crack was noted in the cement-asbestos conduit about 6-1/2 feet from the inside end. Beyond the 10-foot position, any changes that might have occurred were generally small and less than the estimated 0.10-inch possible error inherent in the measuring method. From 28 to 36 feet out, the measured deformations differed slightly from the initial readings for the cement-asbestos conduit, but the changes were upward, a movement which would not be expected. Thus, the data there were considered suspect on initial investigation.
